NOTE OF THE CIAF ON THE INVESTIGATION OF THE ADAMUZ ACCIDENT: UPDATE ON INFORMATION AVAILABLE IN THE FIRST HOURS AFTER THE EVENT

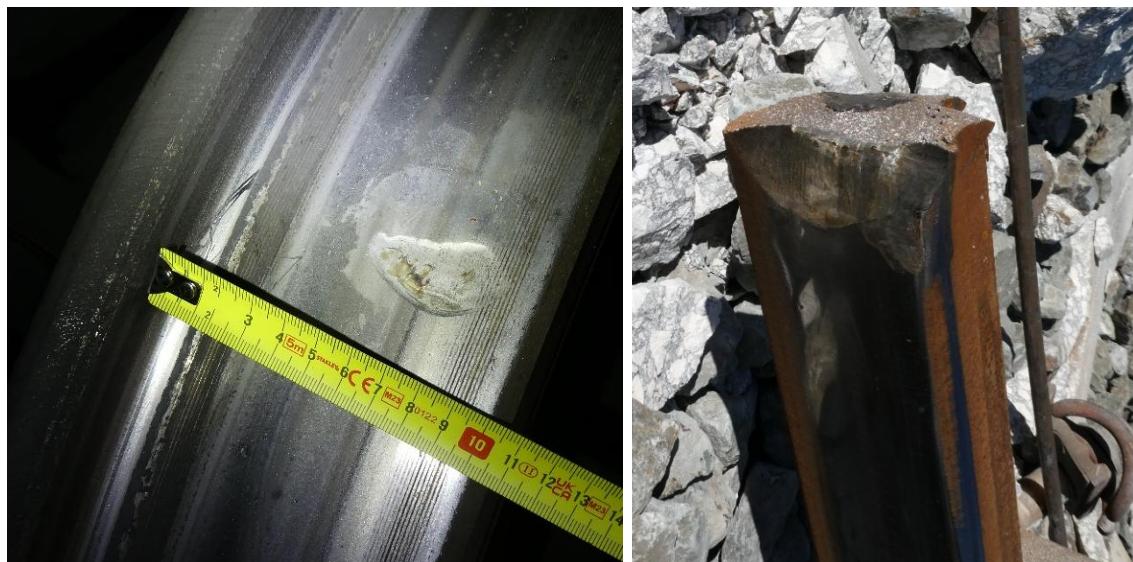
During the inspection of the Iryo train, notches were detected on the tread of the wheels on the right side of carriages 2, 3, 4 and 5. The notches are present on all wheels corresponding to the odd axles of these carriages.

The notches have a uniform pattern in carriages 2, 3 and 4 and are consistent with an impact on the rail head. A visual comparison between the notches on the wheels and the broken section of rail at the derailment site yields presumably matching results:

1: Notches found on the right wheel of axle 13 of the Iryo train (4th carriage, first axle of the first bogie) and possible point of collision with the rail head.

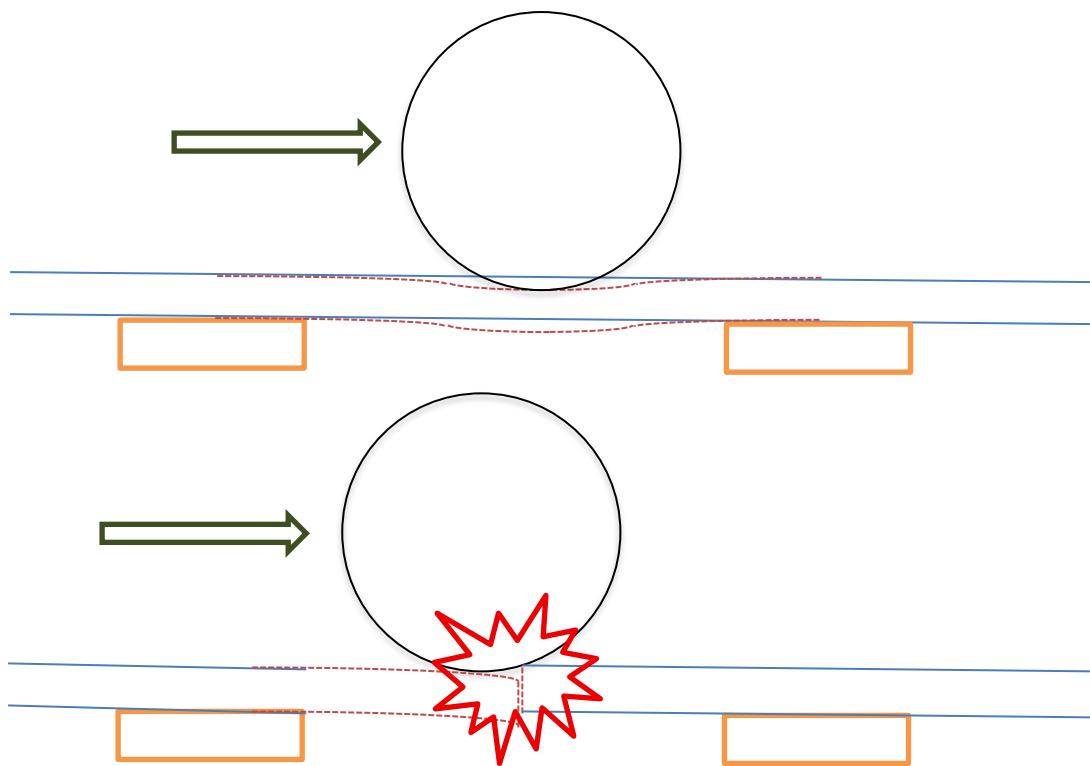
These notches on the wheels and the deformation observed on the rail are consistent with the fact that the rail was fractured: as the continuity of the rail was interrupted, the part before the break would initially receive the total weight of the wheel, causing that part of the rail to drop slightly. As the part of the rail behind the break would not be acting in solidarity with the part in front, a step would momentarily be created between the two sides of the fracture, which would strike the wheel rim.

2: Possible mechanism for the formation of marks on the wheels in the event of a break in the continuity of the rail (consider this a **WORKING HYPOTHESIS**). Above, normal operation (deformation is exaggerated for clarity): the entire rail deforms uniformly under the weight of the wheels. Below, the effect produced by the break in the rail: only the part under the wheel deforms, creating a step that the wheel hits.

Furthermore, the fact that the notches are only present on the wheels of the odd axles of the train is consistent with the fact that the first wheel of each bogie received the impact of the broken rail head, as described above. After that first impact, the struck rail also deforms and descends, due to the impact and to the weight of the first wheel. At speeds of around 200 km/h, the second wheel passes so quickly (around 0,03 seconds later) that the impacted rail does not have time to recover from this deformation and therefore does not strike the second wheel of the bogie as it did with the first.

In any case, this hypothesis to explain the marks on the wheels and the rail will have to be corroborated by detailed calculations and analysis.

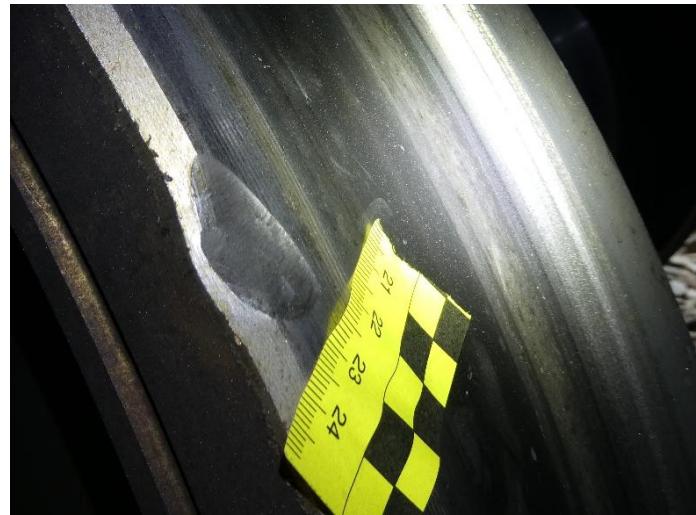
The notches present on car 5 (right wheels of axles 17 and 19) have a different pattern to those on the other cars, but they match each other. These notches consist of a mark on the outer edge of the tread, consistent with an impact against the rail head in a position that is not continuous with the area prior to the fracture. The fact that these notches are found on car 5, and that car 6 was the first to derail from the train, is consistent with the rail tipping outwards (right side in the

direction of travel) during the passage of car 5, so that car 6 derailed due to a complete lack of continuity in the running gear.

3: Notch present on the right wheel of axle 19 of the Iryo train (carriage 5, first wheel, second bogie)

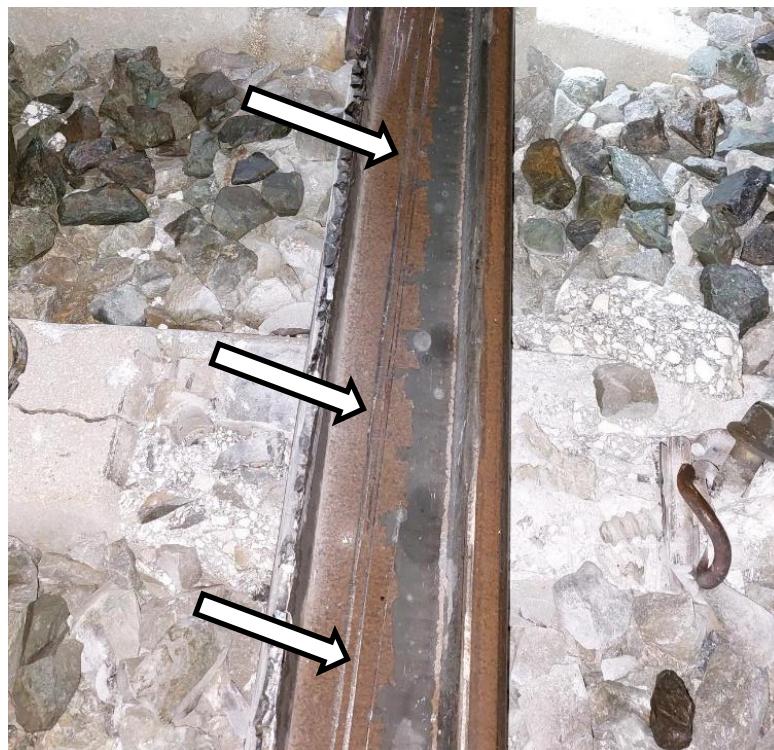
4: Rail lying on its side, after the point of breakage. Traces of the train wheels can be seen on the rail web.

In fact, it was observed on site that the rail, after the point of breakage, had ended up tilted outwards and with marks of having been run over sideways by a wheel, once the rail had fallen over.
